INDOOR AIR QUALITY ASSESSMENT

**Northbridge Middle School
171 Linwood Avenue
Whitinsville, MA 01588**

Prepared by:
Massachusetts Department of Public Health
Center for Environmental Health
Emergency Response/Indoor Air Quality Program
August 2005

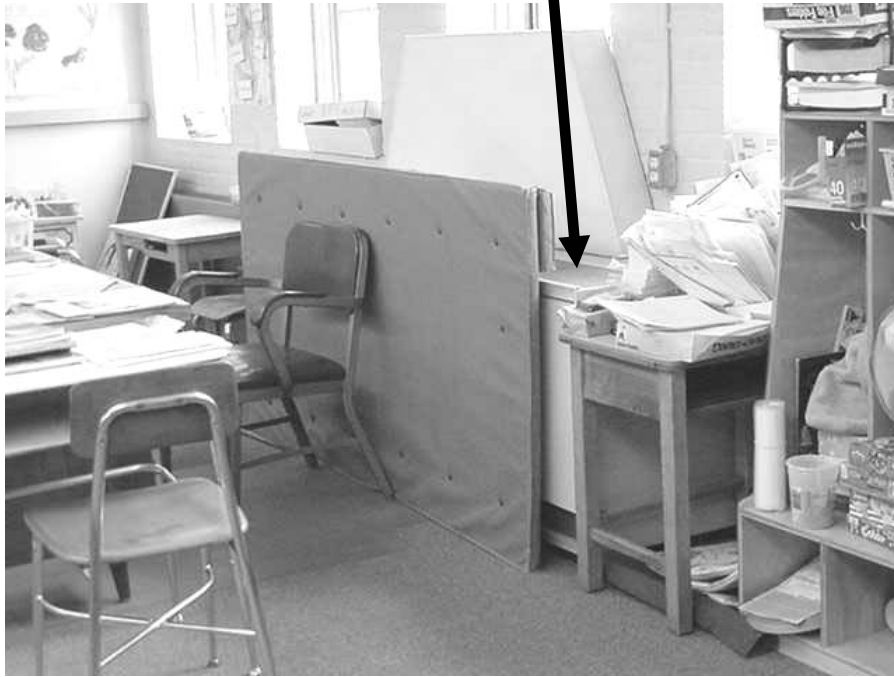
Picture 3

Obstructions to airflow, such as papers and books stored on univents and items placed in front of univent returns, were also observed in a number of classrooms (Picture 3). In order for univents to provide fresh air as designed, these units must remain activated and allowed to operate while rooms are occupied. In addition, univent intakes and diffusers must remain free of obstructions.

Obstruction to classroom univent

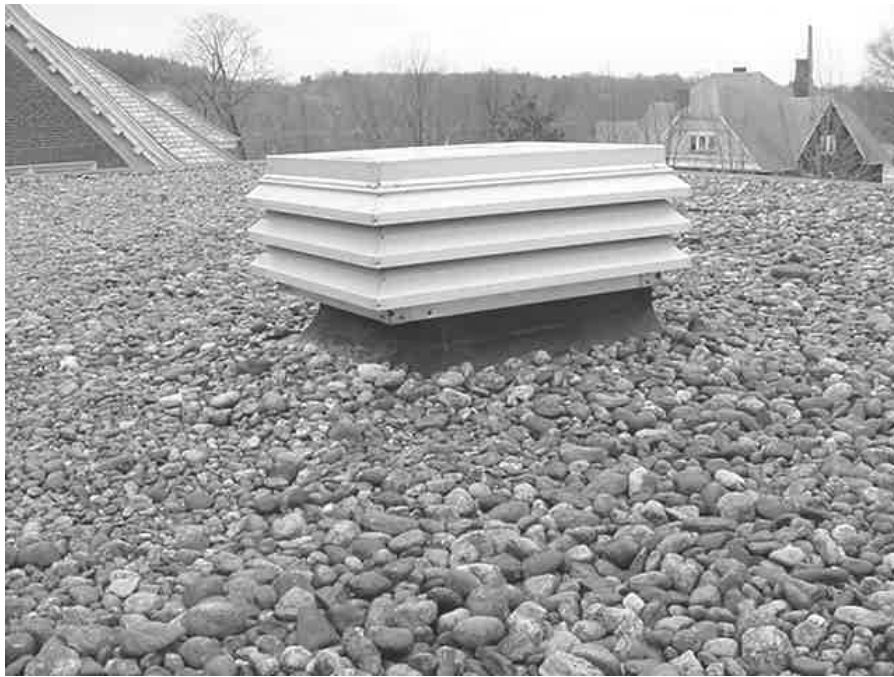
Picture 6

Fresh air intake low to rooftop, less than 6 inches in height

7. Consider extending the height of fresh air intakes for AHUs to prevent snow infiltration.
8. For buildings in New England, periods of low relative humidity during the winter are often unavoidable. Therefore, scrupulous cleaning practices should be adopted to minimize common indoor air contaminants whose irritant effects can be enhanced when the relative humidity is low. To control for dusts, a high efficiency particulate arrestance (HEPA) filter equipped vacuum cleaner in conjunction with wet wiping of all surfaces is recommended. Avoid the use of feather dusters. Drinking water during the day can help ease some symptoms associated with a dry environment (throat and sinus irritations).

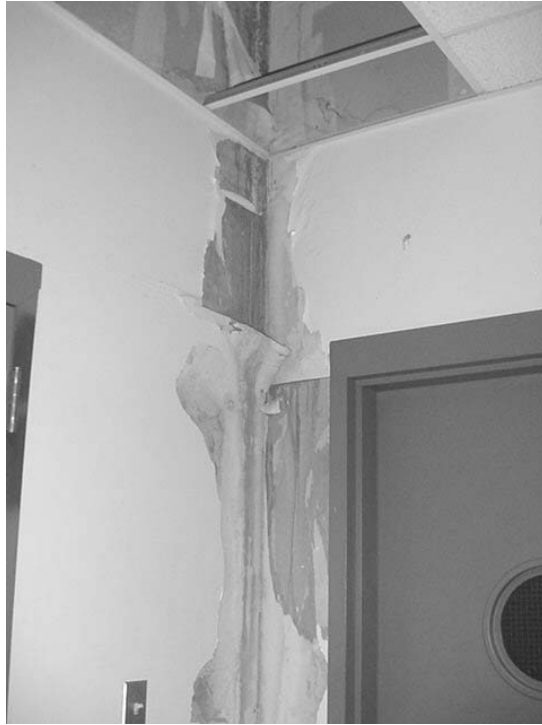
Picture 10

Water damaged GW wall in band room

9. Remove, replace and/or repair water-damaged materials (e.g., ceiling tiles, GW). Examine these areas for mold growth. Disinfect areas of water leaks with an appropriate antimicrobial. Remove water-damaged materials in a manner consistent with *Mold Remediation in Schools and Commercial Buildings* published by the US EPA (2001). This document can be downloaded from the US EPA: http://www.epa.gov/iaq/molds/mold_remediation.html.

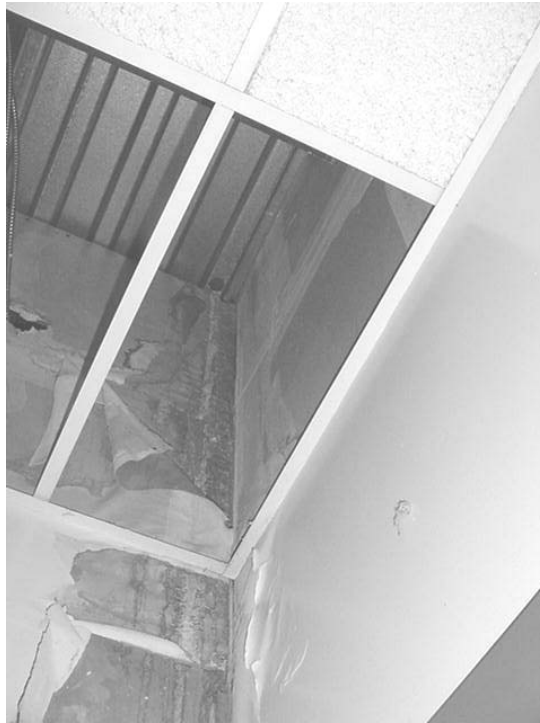
Picture 11

Water damaged GW above ceiling plenum in band room

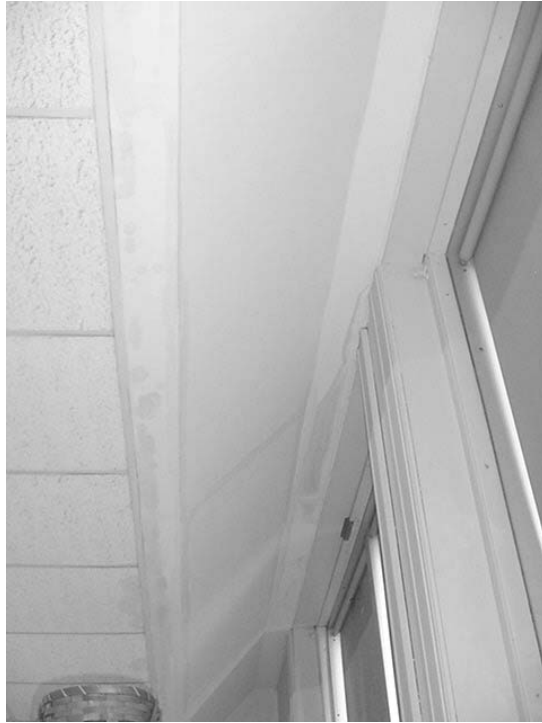
Picture 12

In addition to the band room, materials in other rooms also sustained damage. Water-damaged GW was noted in a number of other areas. Most notably, GW is used for portions of the drop ceiling system in many areas that were water-damaged (Picture 12). GW near a

Water damaged GW used for drop ceiling

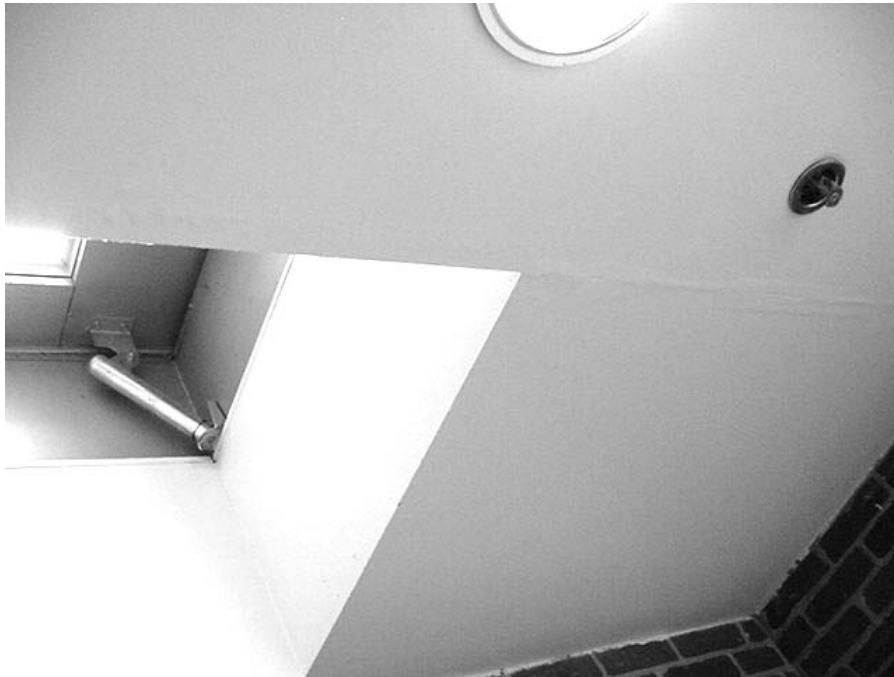
Picture 13

skylight was also observed to be water-damaged (Picture 13). At the time of the assessment, it was unclear where the leak in this area originated. It does not appear that the skylight was the source of leakage, since there is no damage to the GW directly below and around the skylight. It is likely that a roof leak caused the damage and water traveled along a seam between two different sheets of GW.

Water damage near skylight

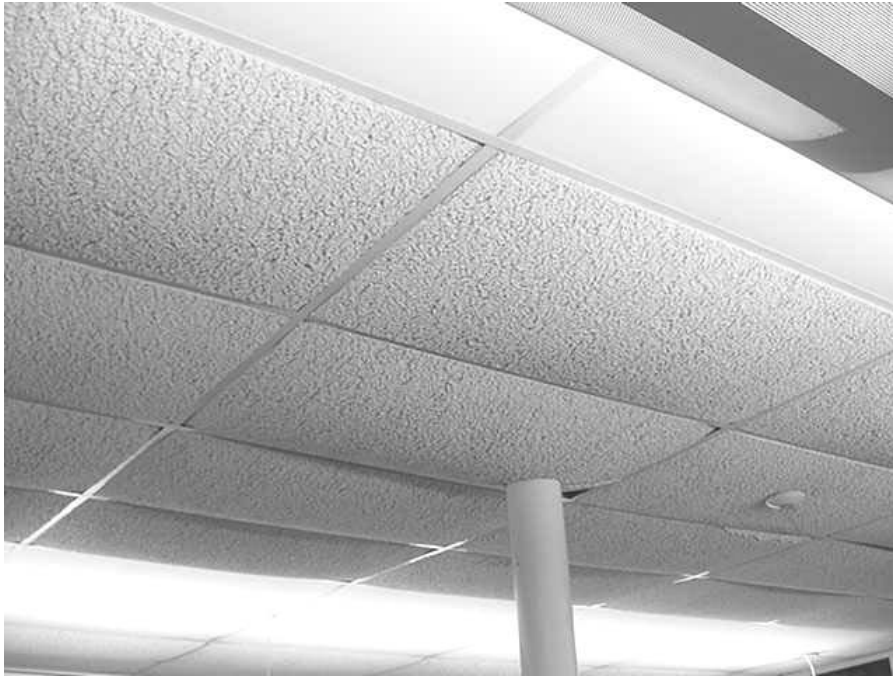
Picture 14

Water-damaged and bowed ceiling tiles were observed (Picture 14). Water-damaged ceiling tiles can provide a source for mold growth and should be replaced after a water leak is discovered and repaired. Bowed tiles are an indication of chronic exposure to a humid environment. Ceiling tiles in a humid environment can absorb moisture from the ambient indoor air. Over time, these ceiling tiles begin to sag, allowing materials to move from the ceiling plenum to occupied spaces. If not dried thoroughly, under certain conditions, bowed ceiling tiles can become a source for mold growth.

Bowed ceiling tiles

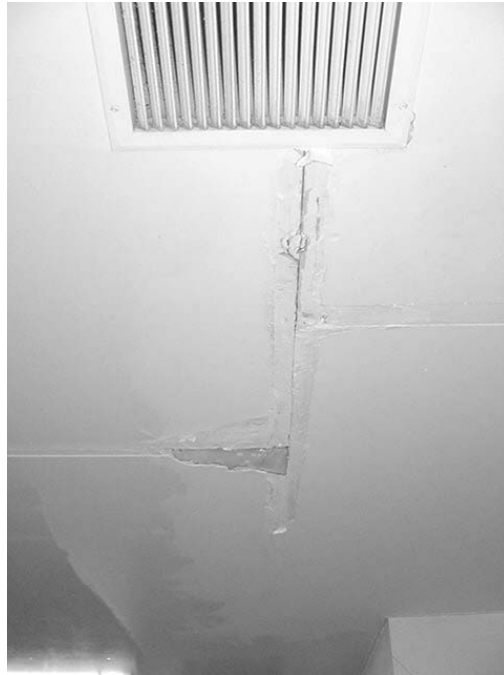
Picture 15

Water-damaged ceiling and wall plaster were also observed throughout the school (Picture 15). Although water-damaged ceiling plaster is not a source for mold growth, moistened dust trapped in spaces between the paint layers can become mold growth media. Other water-damaged materials included a corkboard (Picture 16) and wooden window ledges (Picture 17). Upon discovery, Mr. Halacy promptly made arrangements to remove the damaged corkboard. In

Water damaged ceiling plaster

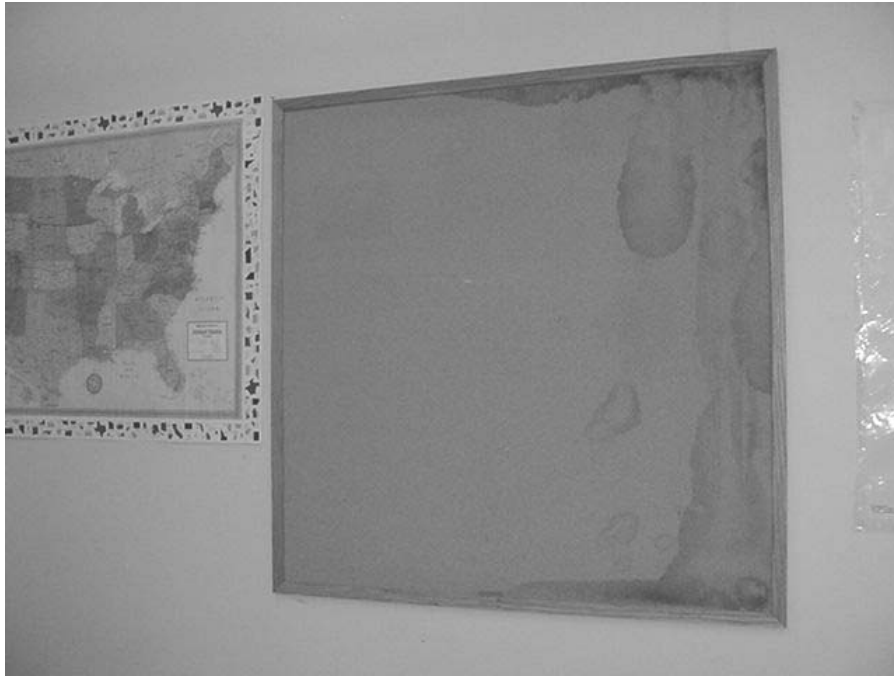
Picture 16

Water damaged corkboard

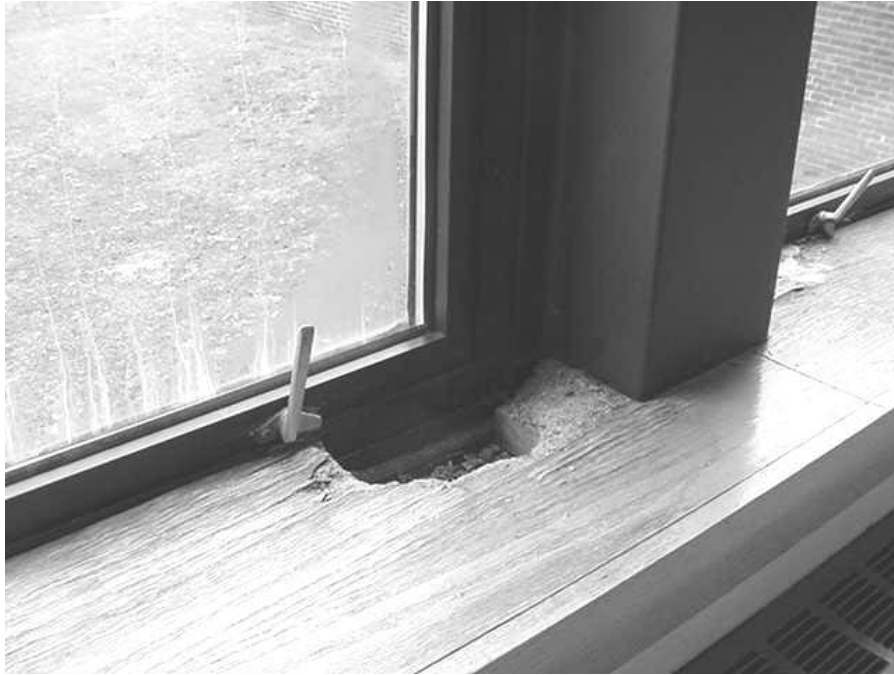
Picture 17

one room, it appeared that a window ledge had sustained both water and termite damage. Measures should be taken to prevent further water damage and potential termite reinfestation. Open seams between the sink countertop and wall were observed in several rooms (Picture 18). If not watertight, water can penetrate through the seam, causing water damage. Water penetration and chronic exposure of porous and wood-based materials can cause these materials to swell and show signs of water damage. As previously discussed, moistened materials that are not dried within 24 to 48 hours can become potential sources for mold growth.

Water and termite damaged wood ledge

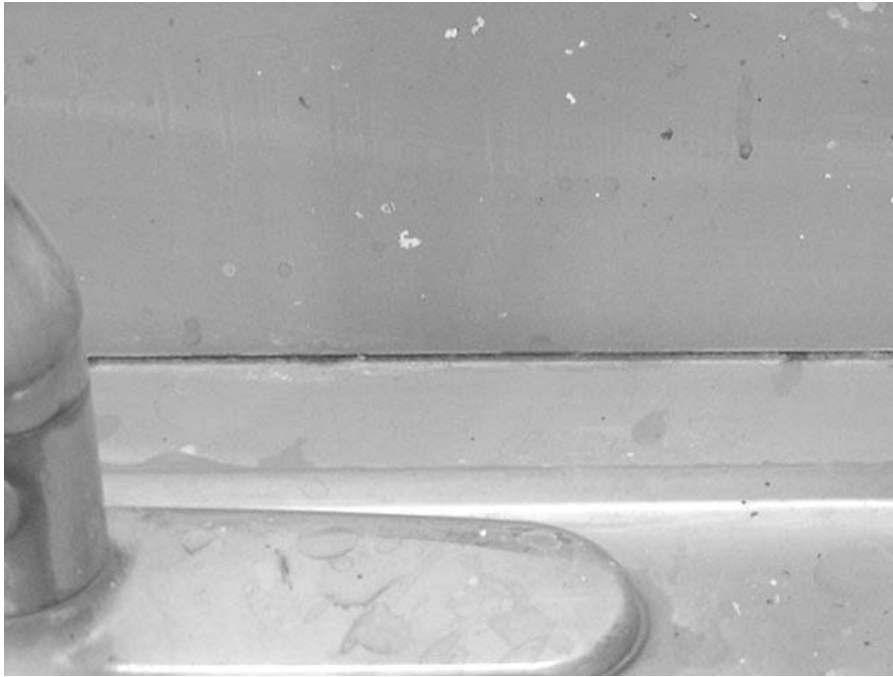
Picture 18

Breach between sink countertop and backsplash

15. Remove clinging plants and shrubbery in close proximity to the building exterior and univent air intakes.
16. Seal breaches, seams, and spaces between sink countertop and backsplash to prevent water damage and/or microbial growth.

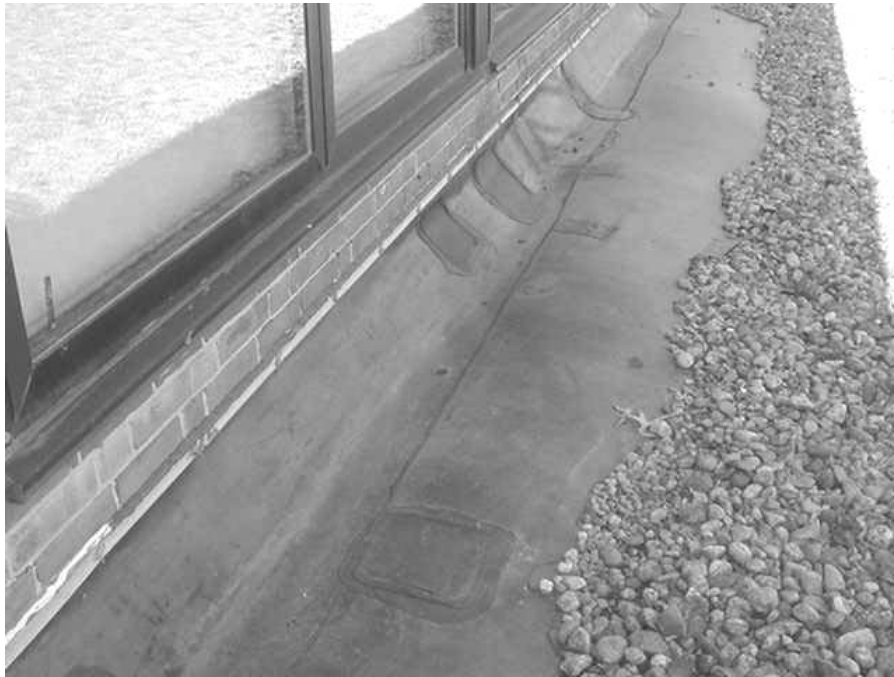
Picture 19

To determine the extent of roof damage, MDPH staff observed roof conditions on both days of the assessment. On March 22, 2005, MDPH staff observed the rubber membrane roof above the auditorium and gymnasium. The roof appeared to be patched in a number of areas. Although the roof membrane is still pliable, the patches are no longer adhering to the membrane. As a result, water can penetrate beneath patches and seals. A number of holes were also noted in the membrane. These holes can become points of water entry. Portions of the roof membrane were bubbled (Picture 19); other portions were pulling away from flashing, creating a rippling effect (Pictures 20). Damaged flashing can be a source for water penetration. Air pockets such as bubbles and ripples allow water to become trapped, damaging building materials beneath the membrane. Furthermore, water trapped beneath a membrane can migrate and disrupt adhesion of the membrane to the roof, further degrading the membrane integrity. In one case, a roof drain was observed to be clogged with leaves and other debris (Picture 21). Roof drains should be cleared of debris to prevent water pooling on the roof. Moss growth was also observed on the roof (Picture 22). Such growth is an indication that water is being retained against the roof.

Patches and bubble on roof membrane

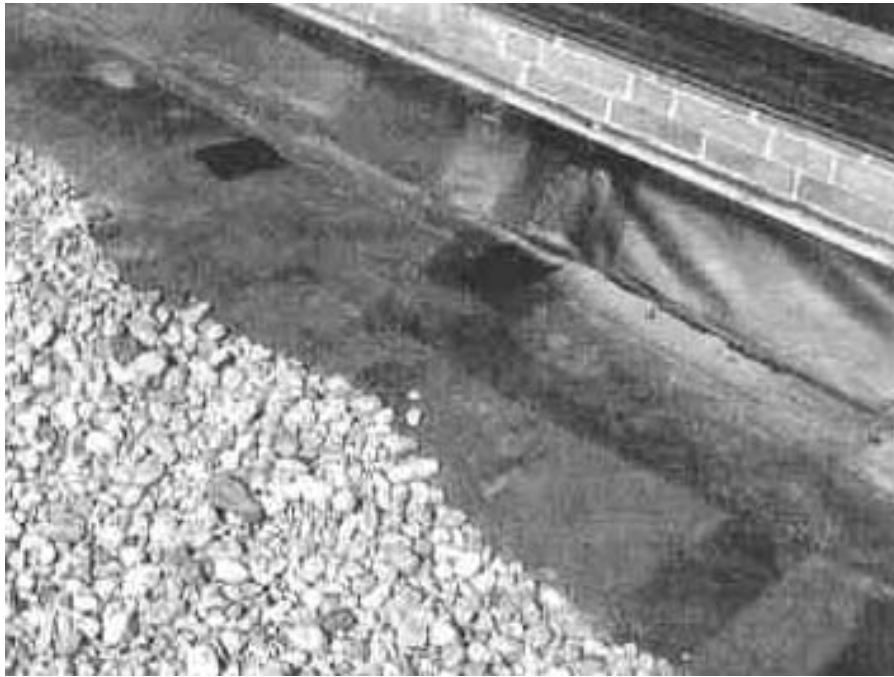
Picture 20

Ripples

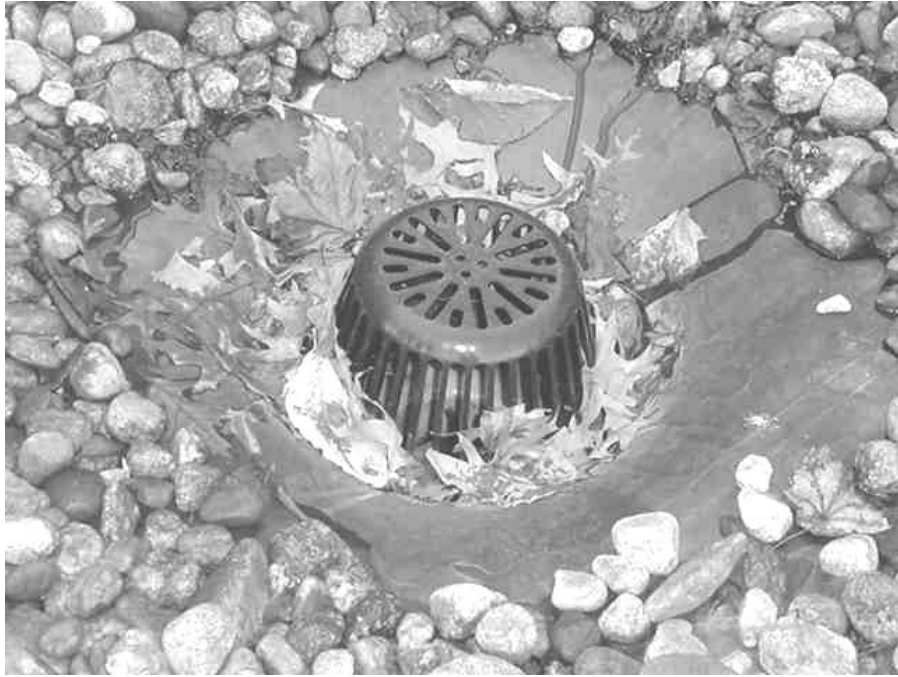
Picture 21

Clogged roof drain

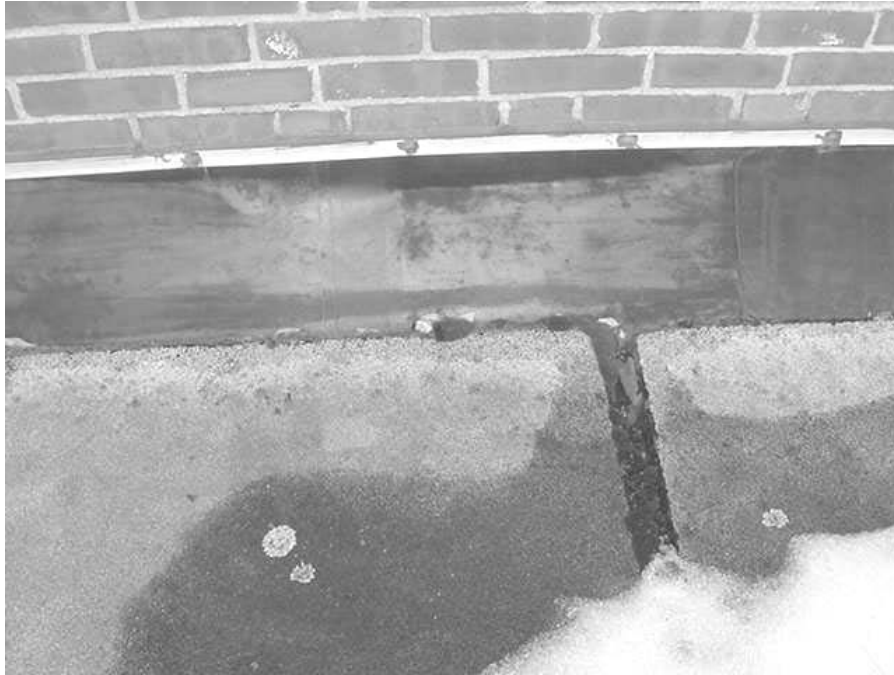
Picture 22

Moss growth on roof membrane

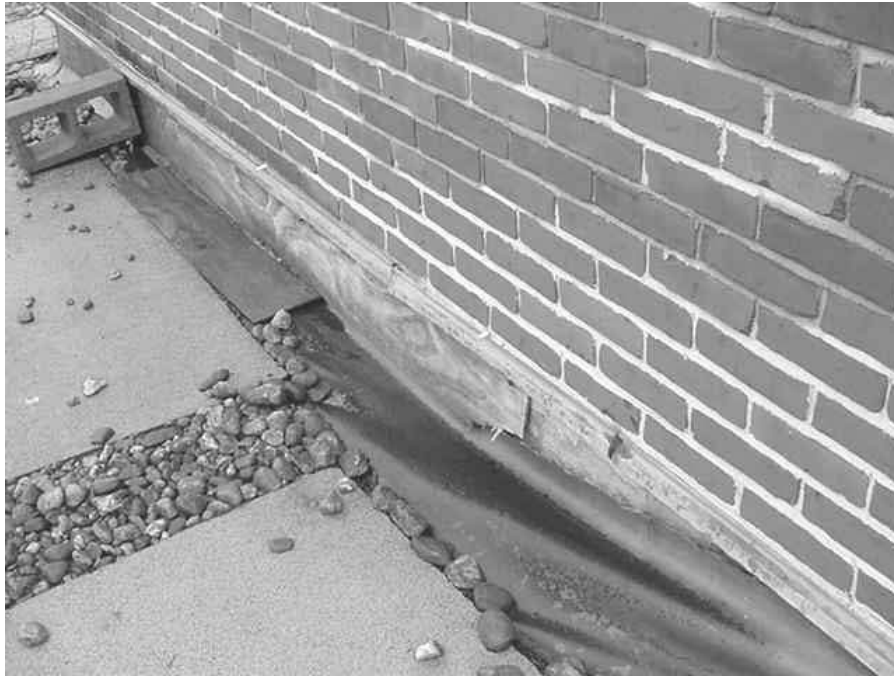
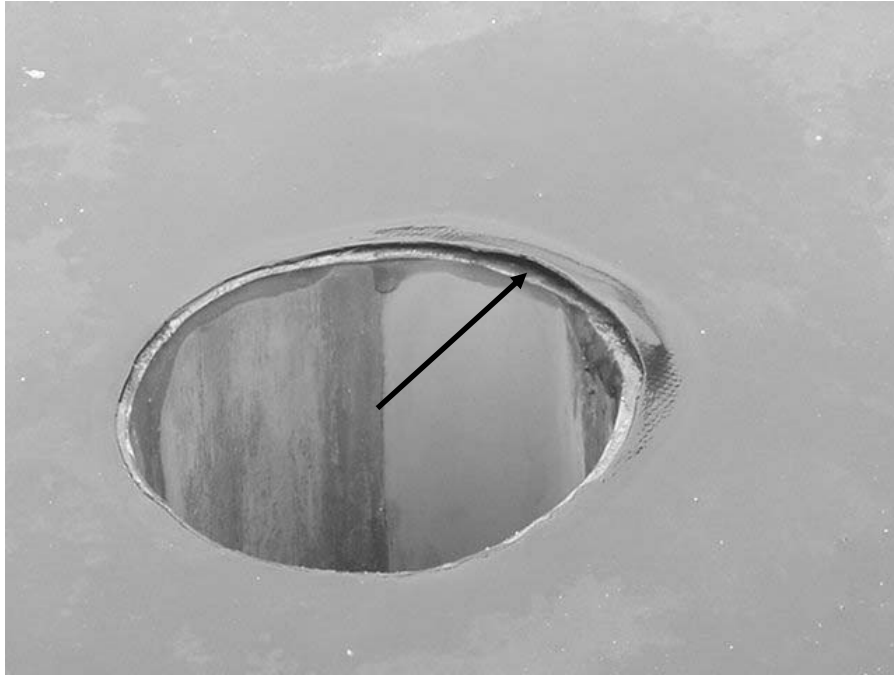
longer adhering to the roof surface (Pictures 23 and 24). A number of patches were also failing (Pictures 25 and 26) and flashing on the roof was damaged, thereby allowing water intrusion. Moreover, rain was observed to be pooling on a number of flat roof surfaces (Picture 27). Over time, pooling water can seep into the building, causing damage to ceiling tiles and other building materials. Freezing and thawing of pooled water can eventually degrade the integrity of the rubber membrane roof, causing cracks to form. These breaches can allow water to penetrate the building.

Sagging roof membrane

Loss of membrane adhesion to roof surface

1. Replace both rubber membrane and slate roofs for all sections of the building to prevent additional damage to building materials.
2. Remove deactivated ventilation towers to prevent debris related damage roof surfaces.

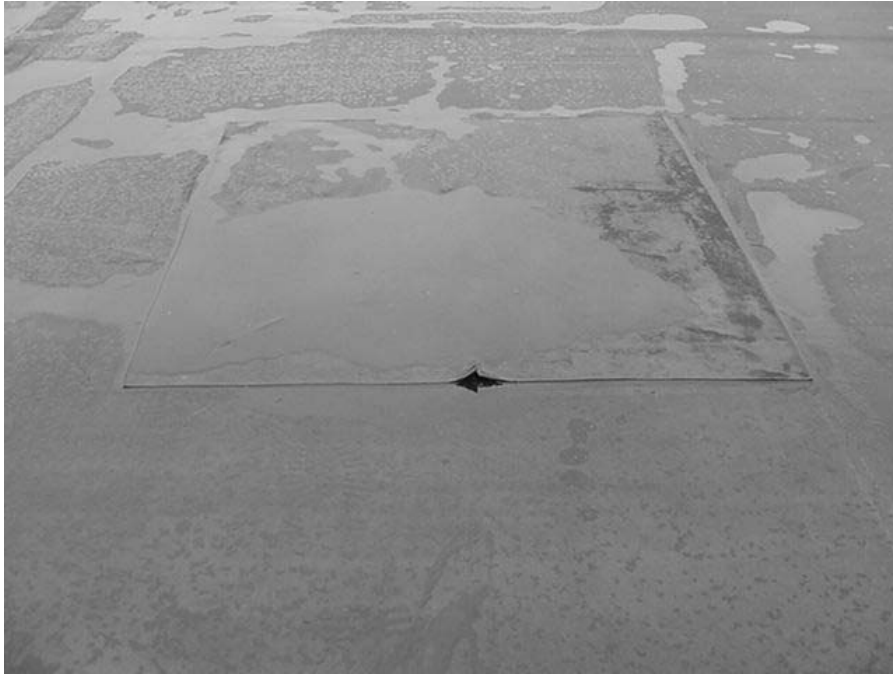
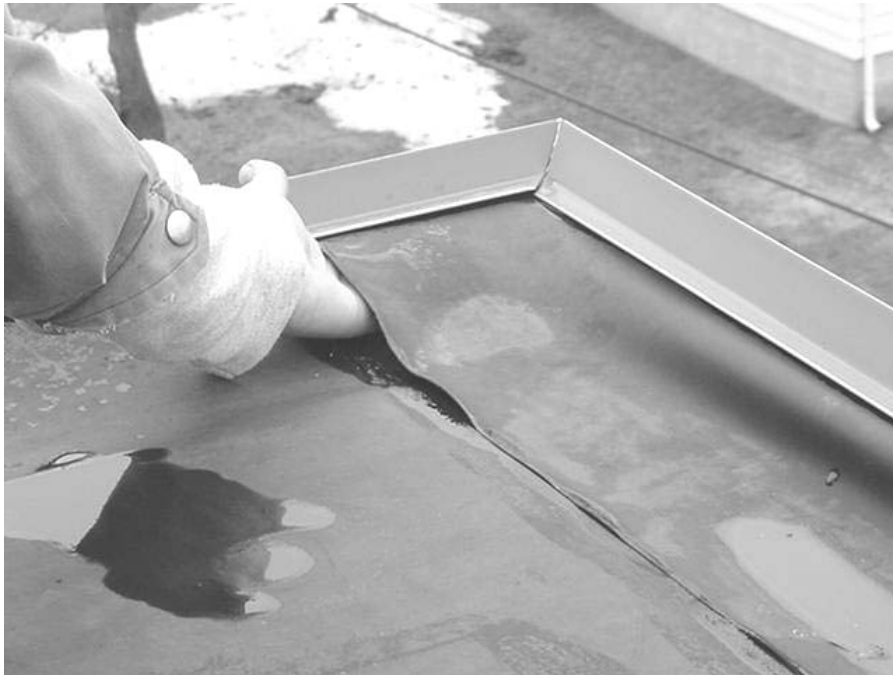
Failing patch

Large breach in membrane

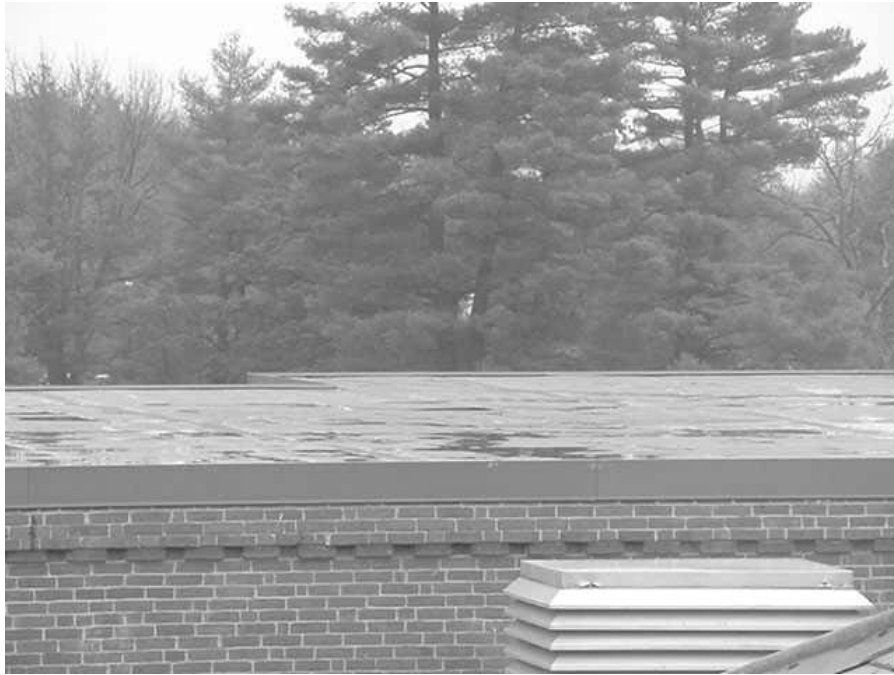
Picture 27

Pooling water on roof

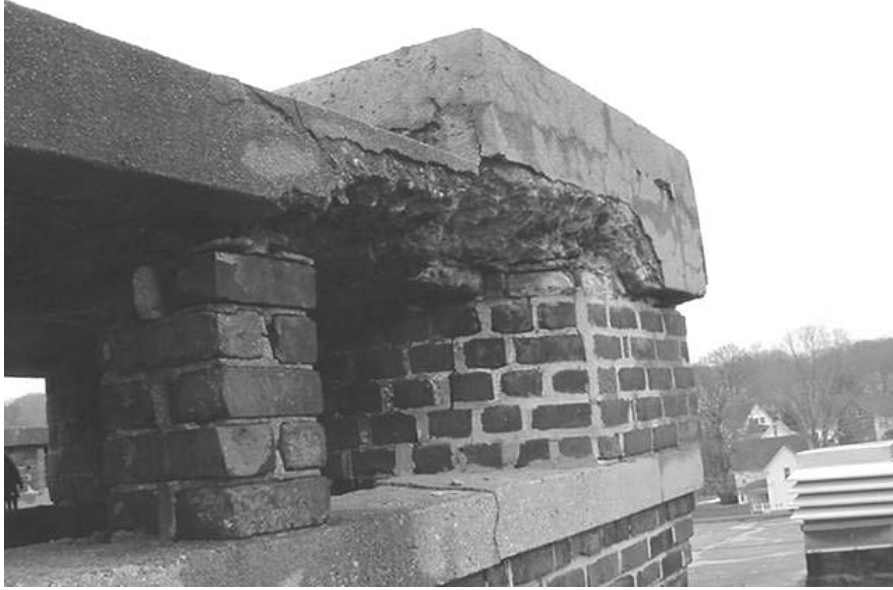
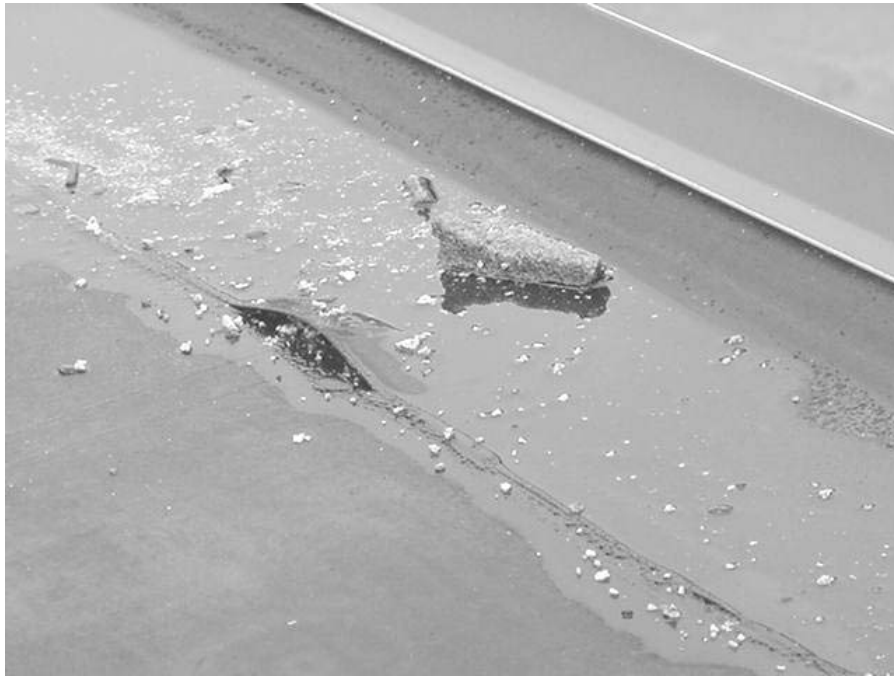
In addition to the normal wear and tear, the roof integrity is also compromised by degrading ventilation towers. These brick structures are severely weathered and are crumbling (Pictures 28 and 29). Debris projected from the tower can damage the rubber membrane. This debris can also become trapped under the roof membrane, further damaging the roof and providing a source for water intrusion. Furthermore, the deactivated towers appear to be serving as bird roosting sites. One tower was partially sealed at the time of the assessments (Picture 30); however, the others were not. Consideration should be given to seal these towers entirely to prevent roosting and degradation, with future plans to remove deactivated towers to prevent debris related damage to the roof membrane.

Damaged tower

Debris from towers, note debris under roof membrane

11. Consider sealing the deactivated ventilation towers to prevent debris from damaging the roof membrane, with plans for removing the towers.
12. Repair gutters and downspouts to prevent water from flowing or pooling against the building.

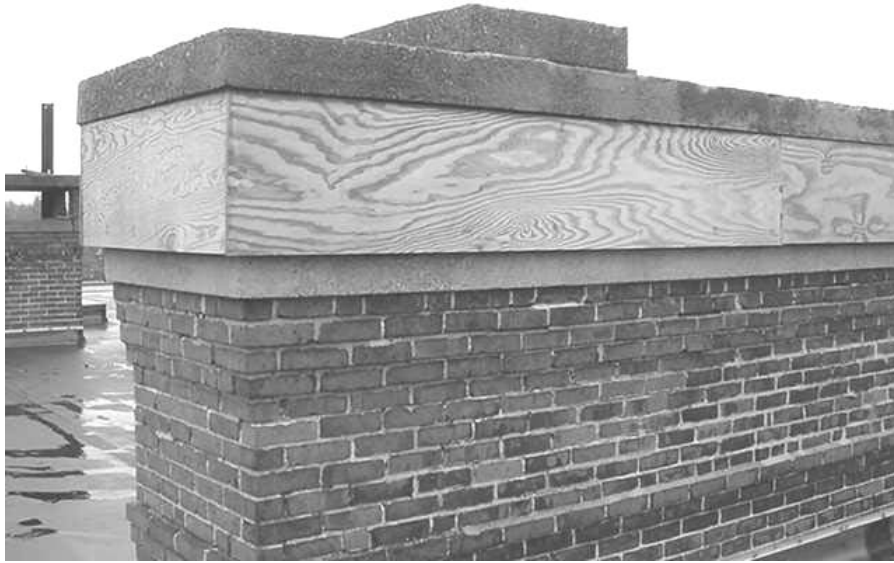
Picture 30

Partially sealed tower, note evidence of slight erosion to top of tower

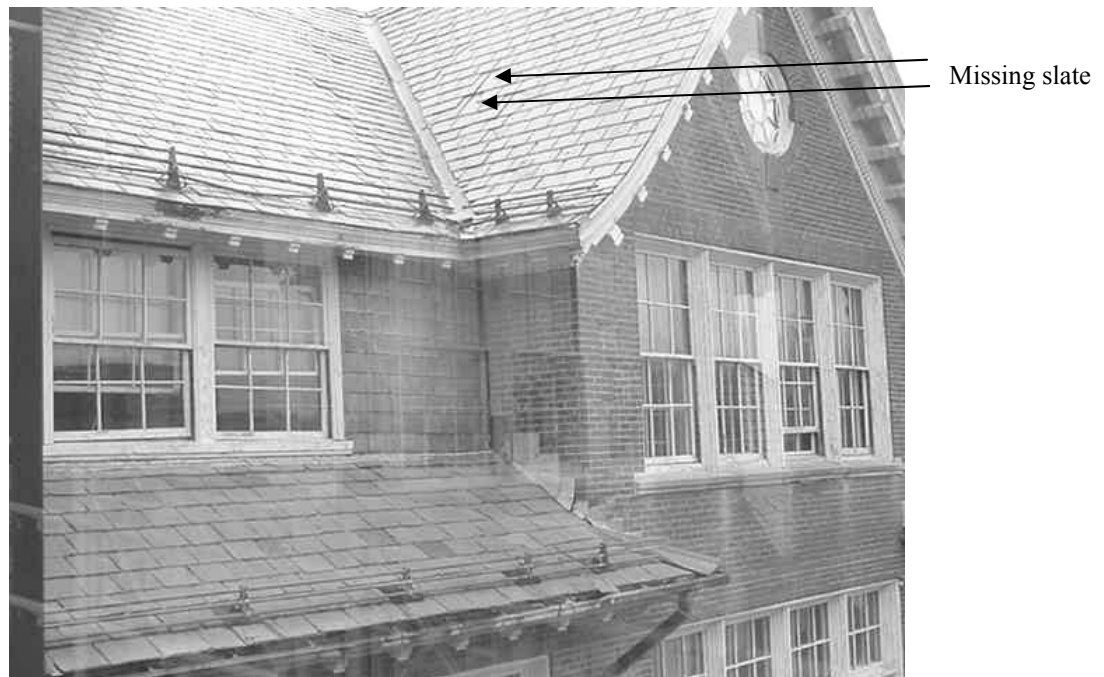
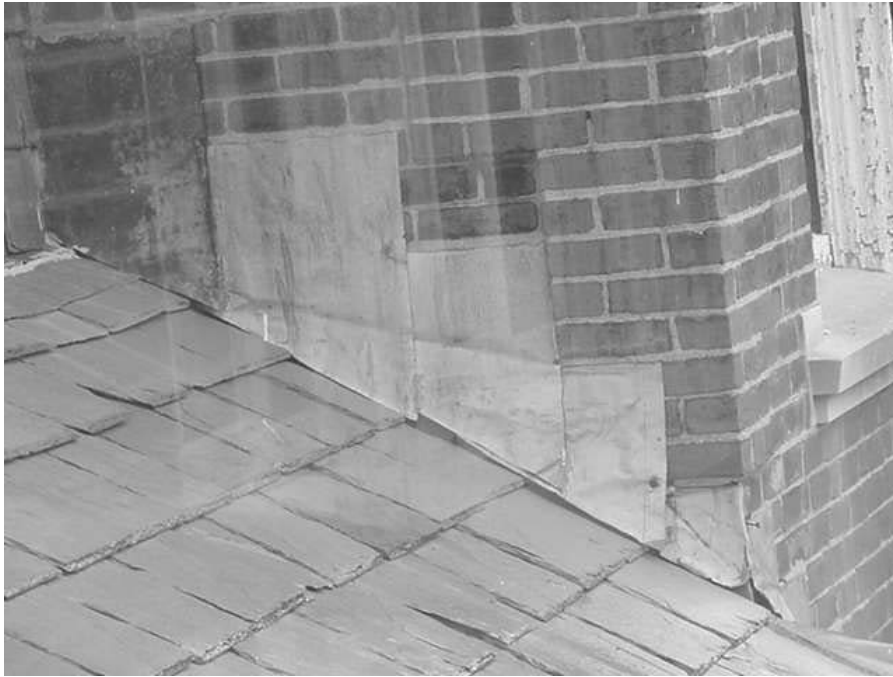
Damage was also observed on the slate roof of the 1905 portion of the building. A number of slate tiles and flashing were missing/damaged (Pictures 31 and 32). In one area, the roof cap and ridge had separated from the roof system (Picture 33). A dislodged roof ridge can be a source for water penetration. In addition, gutters to this portion of the building were significantly damaged (Picture 34). Water from missing/damaged gutters/downspouts can pool against the building, causing damage to the exterior (Picture 35). Similarly, damaged downspouts were observed on the exterior of the modular storage spaces (Picture 36).

Missing and damaged slate roof tiles

Damaged flashing

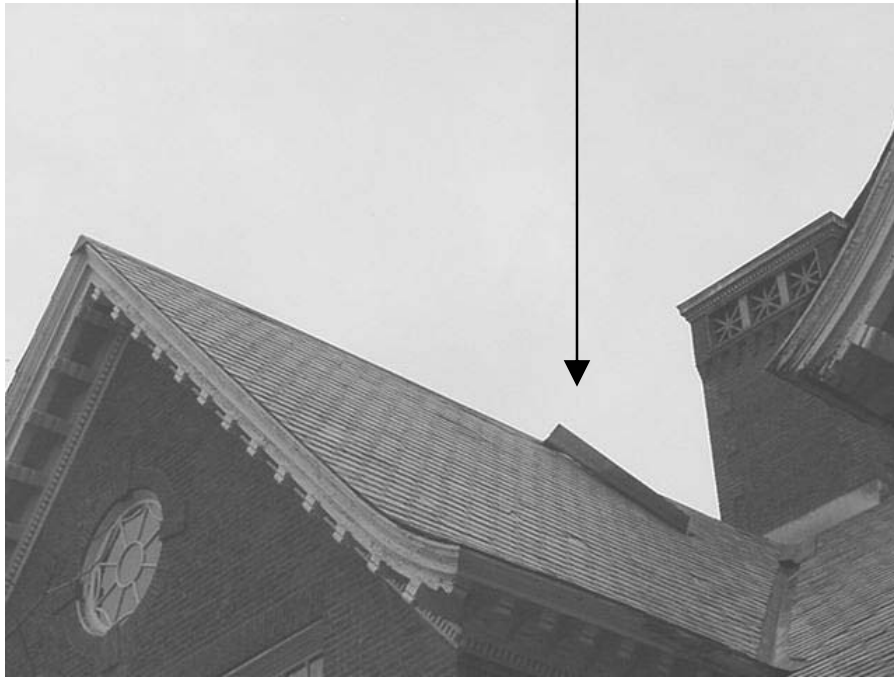
Picture 33

Damaged roof ridge

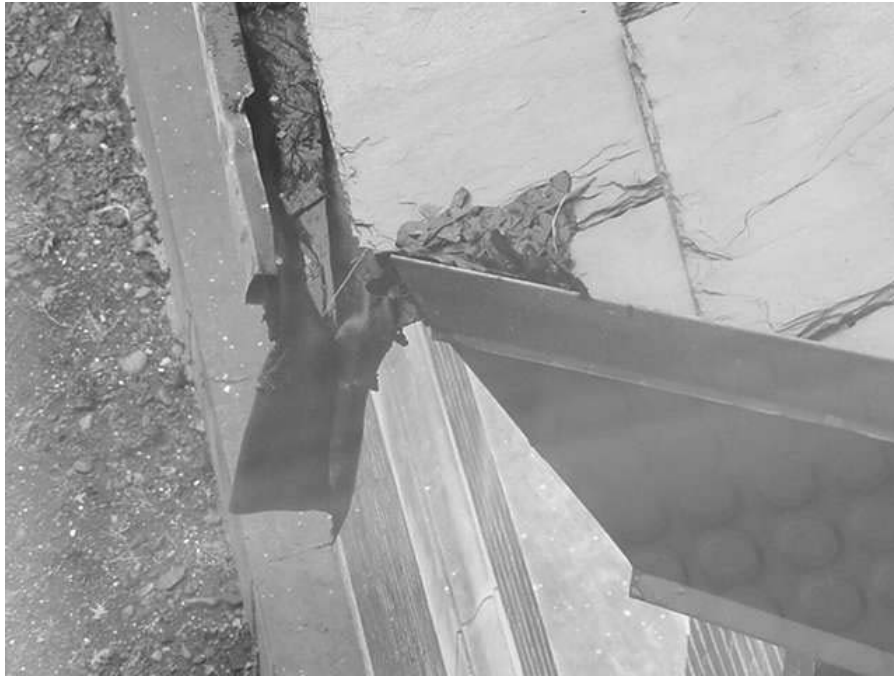
Picture 34

Damaged gutter

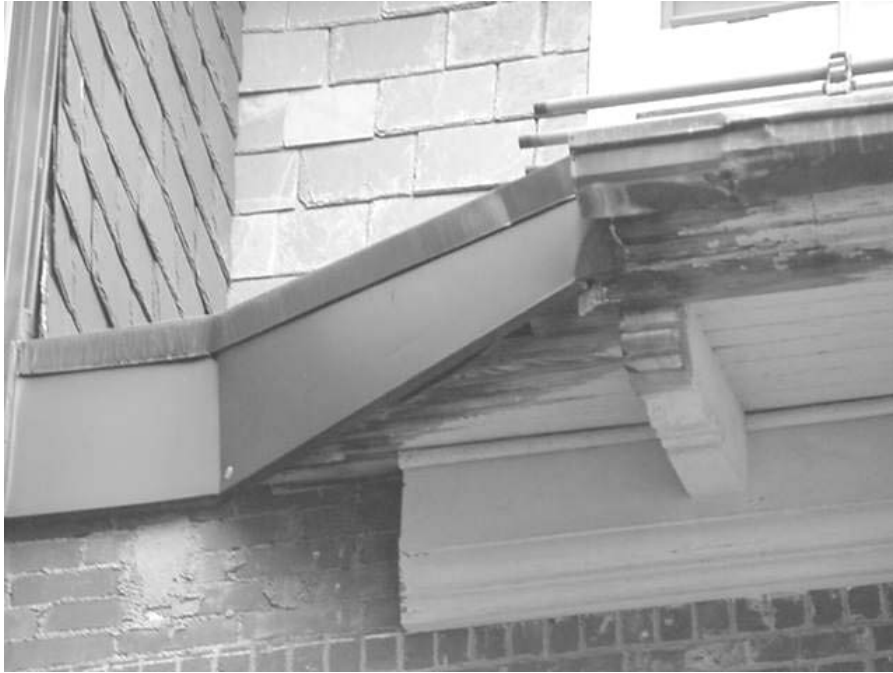
Picture 35

Water damaged soffit wood beneath damaged gutter

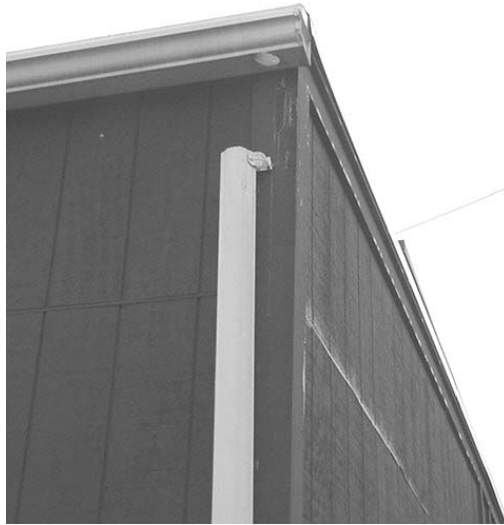
Picture 36

Missing downspout

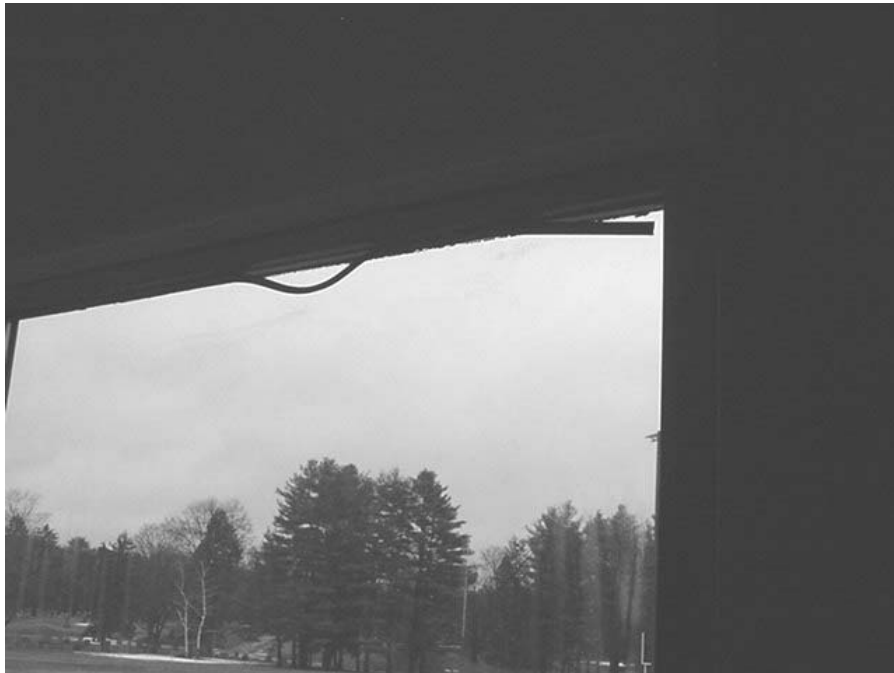
Picture 37

Other sources for water penetration to the building were observed. Breaches were noted in and around the building and its windows. A rubber gasket for a classroom window was also failing (Picture 37). These breaches can serve as points for water entry into the building. Continued freezing and thawing of water during cooler months will serve only to further damage the frame. In addition, breaches can serve as points of entry or shelter for pests. The side paneling to a window bay was noted to be damaged. Since the panel is no longer intact, water can penetrate the building interior.

Failing rubber gasket

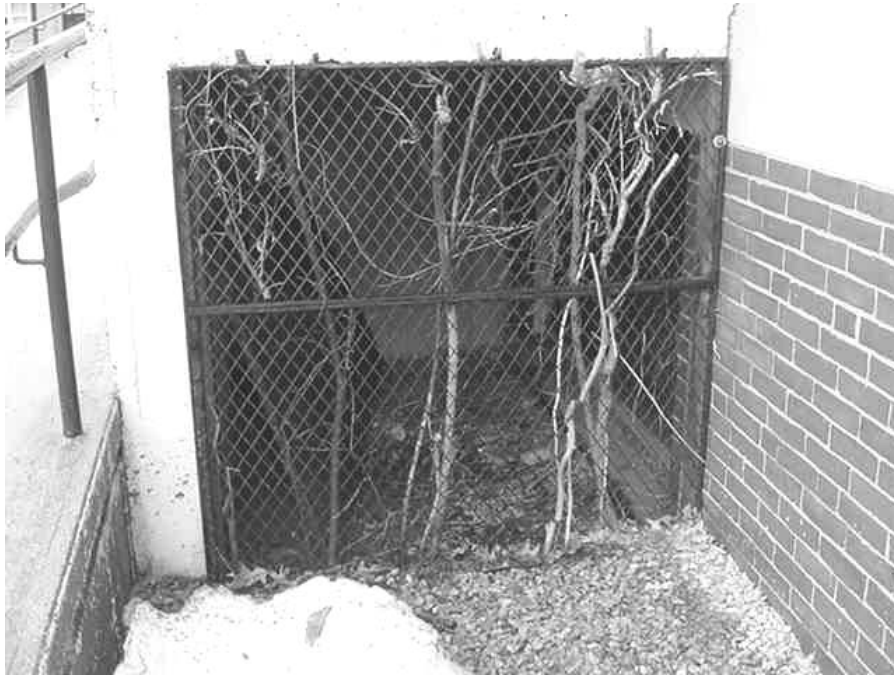
Picture 38

Leaves, debris and plant growth were also noted in a subterranean pit (Picture 38). When moistened, these materials can become a source for microbial growth and odors. Leaves should be removed to prevent growth and odor production. Plant growth should be removed to prevent damage to the foundation.

Plant growth and debris in subterranean pit

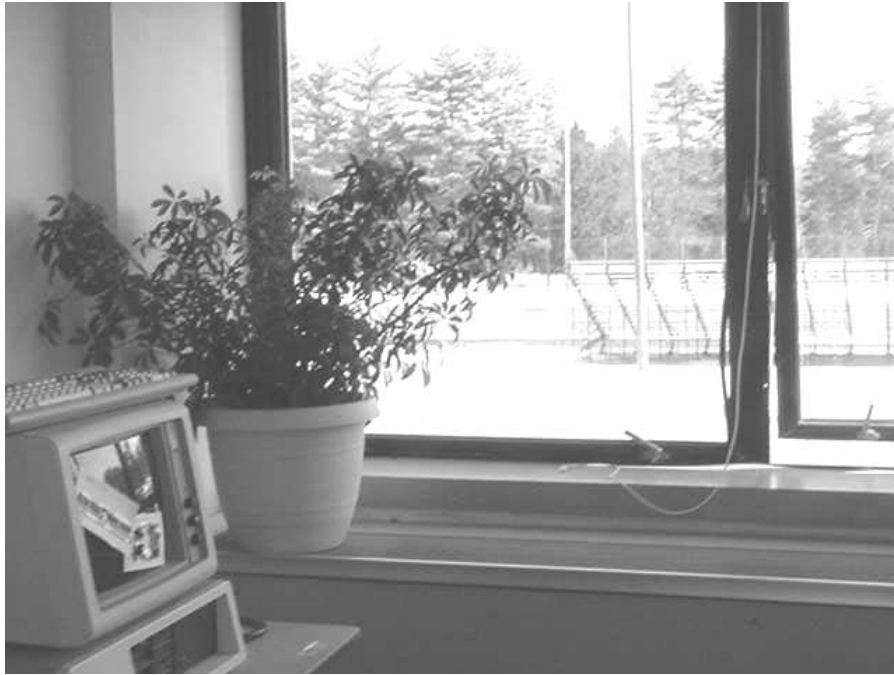
Picture 39

Lastly, plants and potted soil were located in several classrooms. In some classrooms, plants were found on top of univents (Picture 39). Plants, soil and drip pans can serve as sources of mold growth. Plants should be properly maintained, over-watering of plants should be

Plant placed in univent

13. Move plants away from univents in classrooms. Ensure all plants are equipped with drip pans. Examine drip pans for mold growth and disinfect areas of water leaks with an appropriate antimicrobial where necessary. Consider reducing the number of plants.

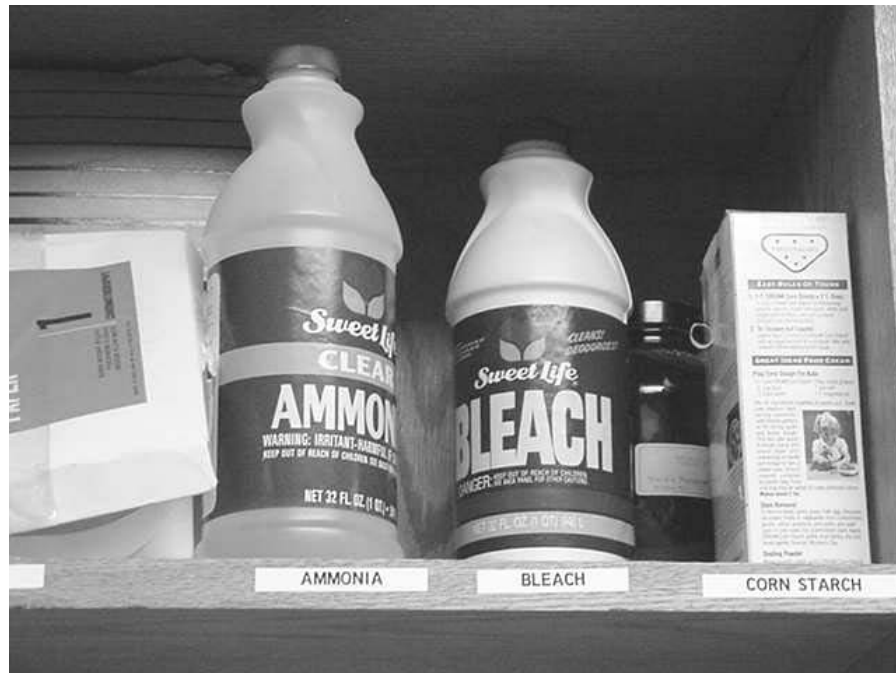
Picture 40

especially in the event of an emergency. Of note is the storage of chemicals in the chemical closet, where ammonia was placed beside the bleach (Picture 40). Mixing these two agents will result in the production of a hazardous gas that can cause serious eye/respiratory irritation and/or bodily harm.

Ammonia placed next to chlorine bleach

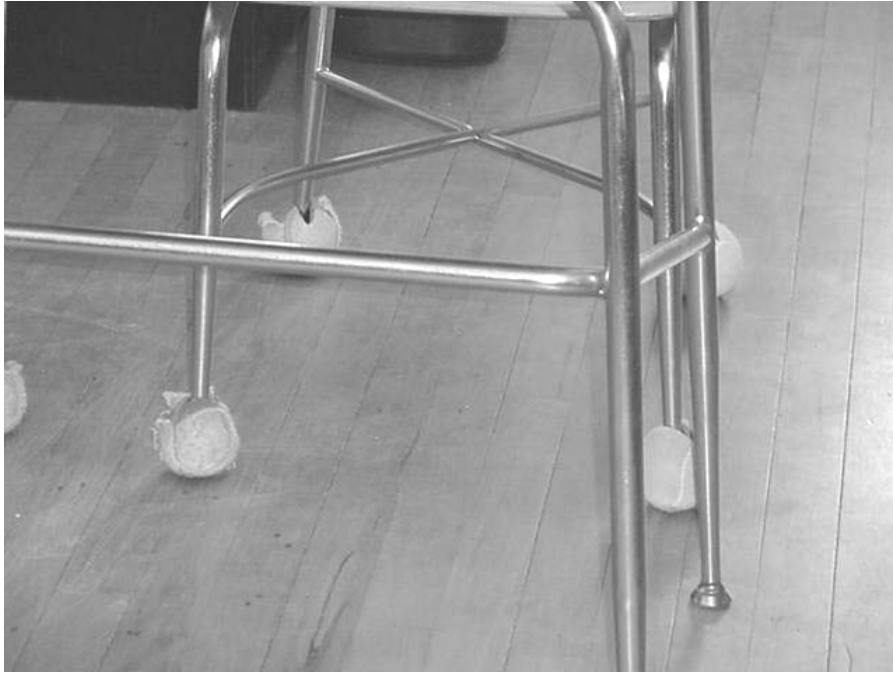
Picture 41

Lastly, in an effort to reduce noise from sliding chairs, tennis balls had been sliced open and placed on chair legs (Picture 41). Tennis balls are made of a number of materials that are a source of respiratory irritants. Constant wearing of tennis balls can produce fibers and off-gas VOCs. Tennis balls are made with a natural rubber latex bladder, which becomes abraded when used as a chair leg pad. Use of tennis balls in this manner may introduce latex dust into the school environment. Some individuals are highly allergic to latex (e.g. spina bifida patients) (SBAA, 2001). It is recommended that the use of materials containing latex be limited in buildings to reduce the likelihood of symptoms in sensitive individuals (NIOSH, 1997). A

Tennis balls on chair legs
